Airborne Wire & Cable Repair Using 135°C PRT-ES Tubing

Presented April 20, 2011
2011 Aircraft Airworthiness & Sustainment Conference,
Session: EWIS A
San Diego, California

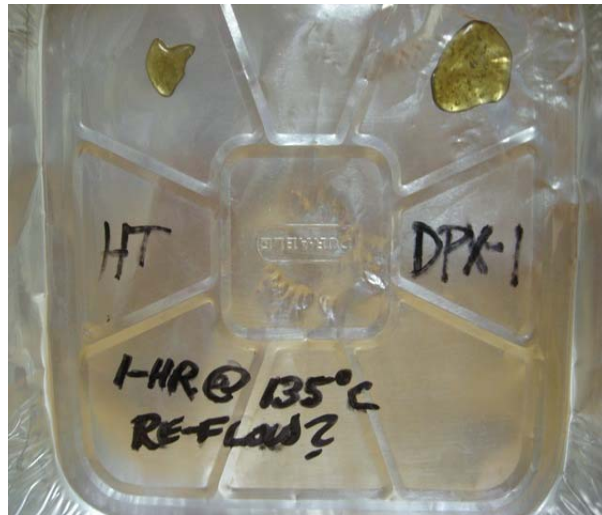
After the molten samples had cooled to room temperature, the aluminum tray was placed in an oven at 125+/-1°C. After one hour of heat soak, both adhesive masses were probed using a metal rod to determine the degree of softness. The ES tape sample was soft and sticky. The metal probe easily penetrated the adhesive mass and created strings of material sticking to the rod upon removal. The HT adhesive was firm, could not be penetrated by the rod and no stings of material clung to the metal rod. The procedure was repeated with the oven temperature raised to 135+/-1°C. The ES material exhibited similar results as seen at 125°C but the HT material was still firm and the probe would not penetrate the adhesive mass. It was possible to create shallow marks in the adhesive surface but there were no strings or signs of the material sticking to the metal rod. (Photo 1)

Photo 1: Horizontal Tray (1-Hour @ 135°C)

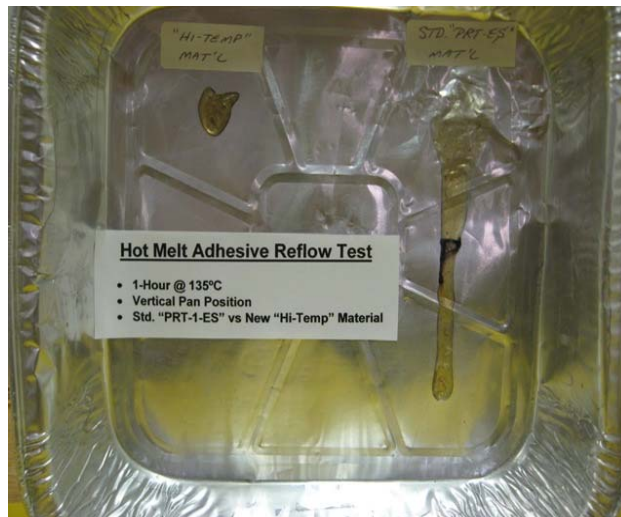
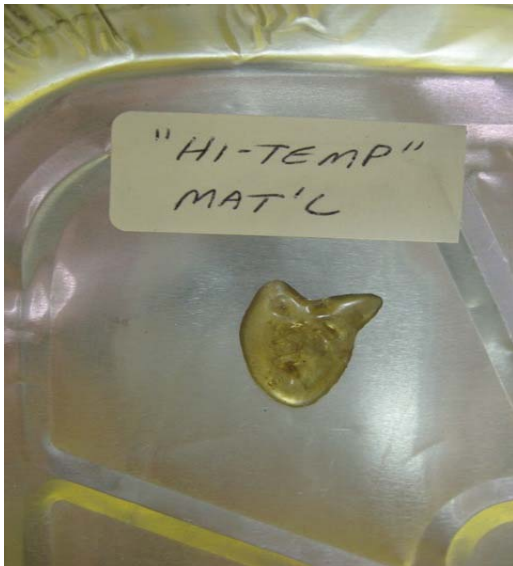
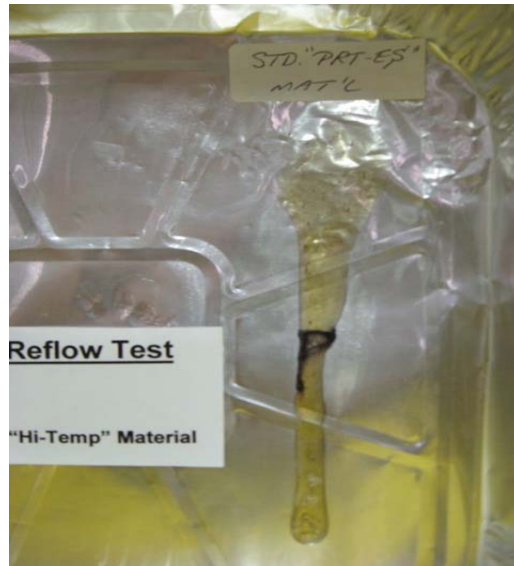
The aluminum tray was returned to the 135+/-1 °C oven with the tray orientated in a vertical position to determine if the adhesive would flow or retain their shape? Upon removal it was evident that ninety-five percent of the ES material puddle had flowed and become a streak six to seven inches long. The original puddle shape was gone and only a thin film of adhesive remained. There was no evidence of the original 1/8" thick raised mound of adhesive where the flow had started. Conversely, the HT material had not flowed and it retained its original puddle shape and the 1/8" thick mound of adhesive. (Photos 2, 3 & 4)

Photo 2: Vertical Tray (1-Hour @ 135°C)

Photo 3: HT adhesive (close up)

Photo 4: ES adhesive (close up)

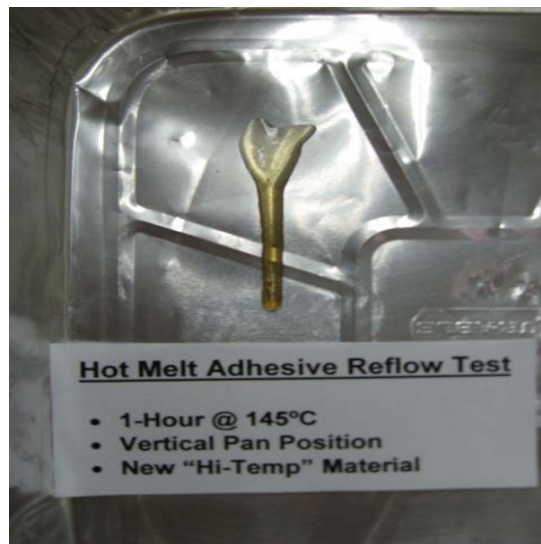
This process was repeated with the temperature raised to $145 \pm 1^\circ\text{C}$. Upon removal it was evident that the HT adhesive had finally reached its flow temperature. Approximately fifty percent of the HT material mass had begun to flow down the pan several inches. (Photo 5) It is interesting to note that at 145°C the entire HT adhesive puddle had not disappeared, a distinctive "V" shape was visible within the puddle inferring that it had reached its flow temperature, but still retained some degree of pastiness.

Photo 5: HT, vertical tray (1-hour @ 145°C)

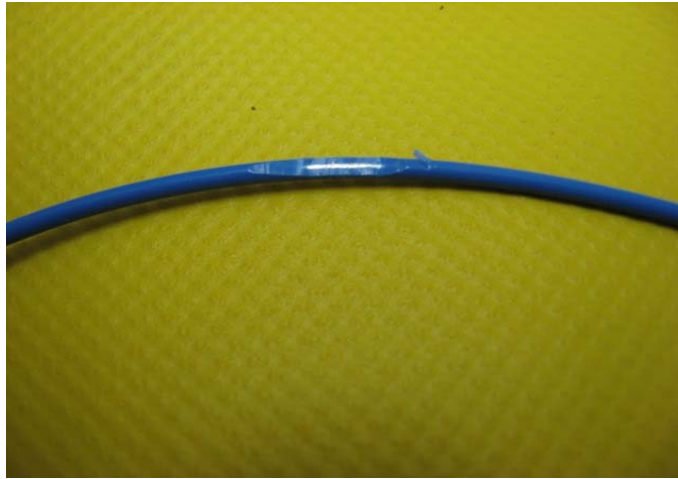
A total of twenty-four samples of PRT-1-ES tubing were created using the original ES adhesive and the new HT adhesive. The repair sleeve assemblies were identical to the PRT-1-ES design that is defined in Zippertubing drawing ZT03-04-010-01 and had been previously tested by NAVAIR. All samples were installed on 22 AWG (0.076" diameter) Teflon insulated wire. Each wire sample had a half inch area of insulation scraped off exposing the wire strands. (Photo 6) The installation process followed the standard PRT-1-ES Installation instructions defined in Zippertubing's installation document ZT03-98-001 and in the NAVAIR 01-1A-505-1 repair manual.

Photo 6: Simulated wire insulation damage

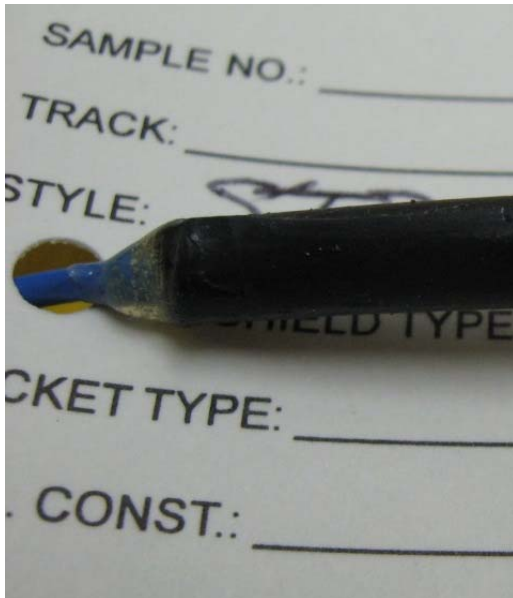
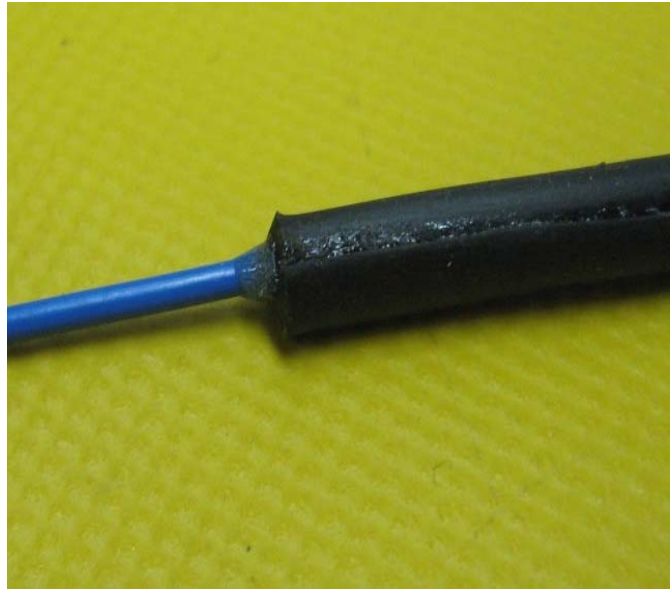
Fabrication of the PRT-1-ES repair sleeves using the standard ES adhesive yielded finished assemblies with large, bulbous adhesive fillets at the ends. (Photo 7) Samples created using the HT adhesive required and additional 30-60 seconds of heat exposure to allow the adhesive to flow plus an additional 30 seconds to create small tapered adhesive fillets at the ends. The resulting HT adhesive fillets were smaller and much less pronounced than those created using the ES adhesive. (Photo 8) The additional heat soak time was required because all samples were fabricated using the same heat gun temperature settings (140-160°C). Zippertubing does not recommend increasing the air stream temperature when using HT adhesive because this could result in blistering the Polyolefin tubing material. Assembly time increased approximately 1-2 minutes using the HT adhesive. The HT adhesive assemblies exhibited several processing advantages over the original ES system. First, the end fillets can be dressed easier since the HT adhesive does not flow as easily. The molten material is more localized and has less of a tendency to be blown around the wire by the air stream. Second, ruptures at the tubing's overlap seam do not occur as easily because the adhesive is not expanding and bubbling as much inside the tubing. The overall result is that the HT adhesive reacts slower to heat and is more controllable during the installation process.

Photo 7: Large ES fillet

Photo 8: Smaller HT fillet

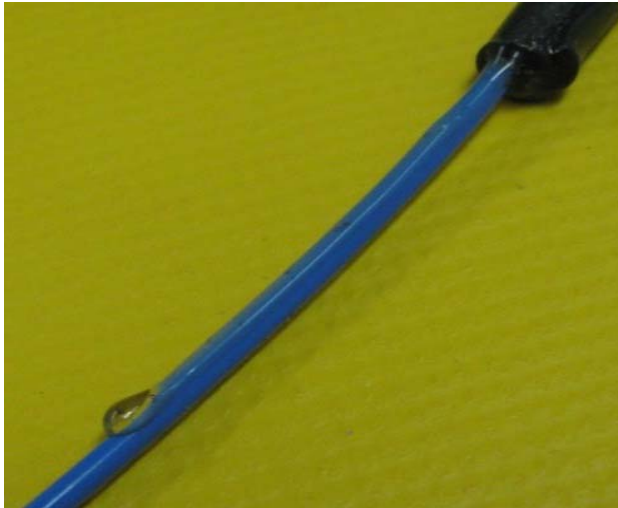
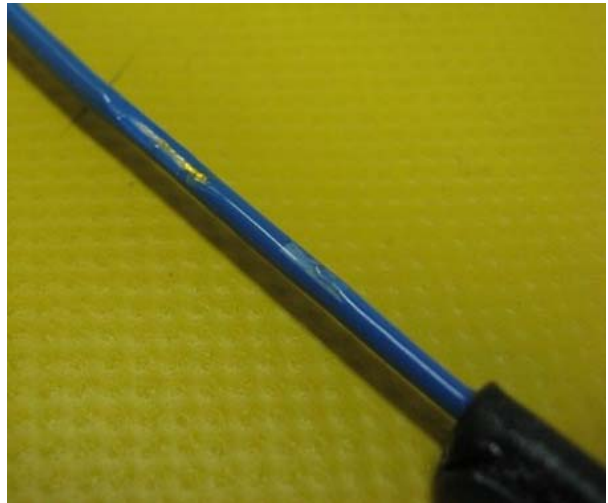
The test was repeated with the second set of six samples except the heat exposure duration was increased from one to four hours. Photo 9 & 10 show the potential adhesive flow and repair sleeve slippage of the original ES adhesive when exposed to 135°C temperatures. Results were the same for both the one and four hour exposure samples. Photos 11 A & B illustrate the lack of any change to the HT sample sleeves. Fillet shapes and sleeve position on the wire did not change in any test sample for either the one or four hour exposures.

Photo 9: ES flow (4-Hours @ 135°C)

Photo 10: ES slippage (4-Hr @ 135°C)

Six repaired wire samples of each adhesive type were suspended vertically across the top of test oven. An aluminum tray was placed below the wires to catch any drips or debris. The samples were exposed to a temperature of $135 \pm 1^\circ\text{C}$ for one hour. After exposure the samples were examined for adhesive flow, drips or other signs of degradation. The six samples made using the ES adhesive all failed! All samples showed evidence of severe adhesive flow from the lower end of the repair sleeve. Furthermore, in all six cases the repair sleeve actually moved down the wire length from its installed location from $3/4$ to 2 inches. As a result, the bare conductor defect area of each wire was exposed! None of the six HT adhesive samples showed evidence of change with respect to fillet shape or sleeve location.

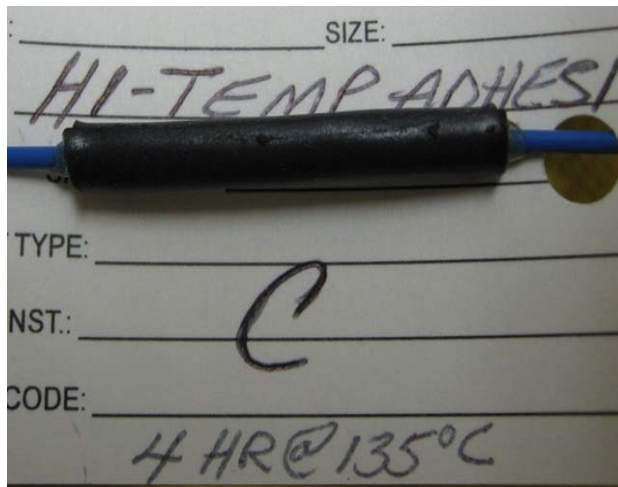
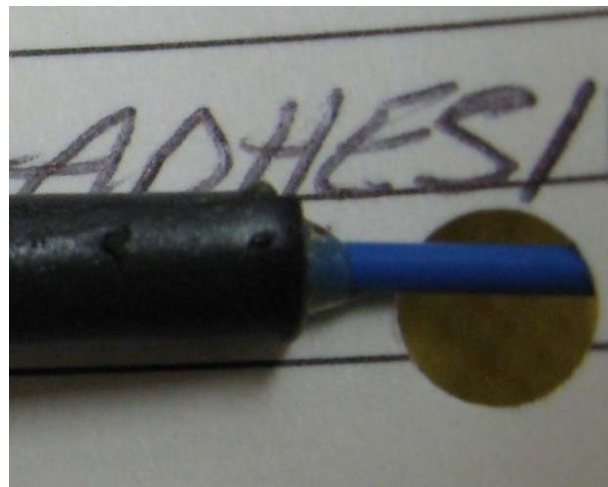
Photo 11A: HT sleeve (4-Hour @ 135°C)

Photo 11B: HT fillet (4-Hour @ 135°C)
