WRAP AROUND HEAT SHRINKABLE TUBING

Presented April 22, 2008
11th Joint NASA/FAA/DoD Conference on Aging Aircraft,
Session: EWIS – Maintenance of Wiring Systems
Phoenix, Arizona

THE ZIPPERTUBING COMPANY
13000 S. Broadway, Los Angeles, CA 90061
(800) 321-8178 ~ Fax (310) 767-1714 ~ www.zippertubing.com

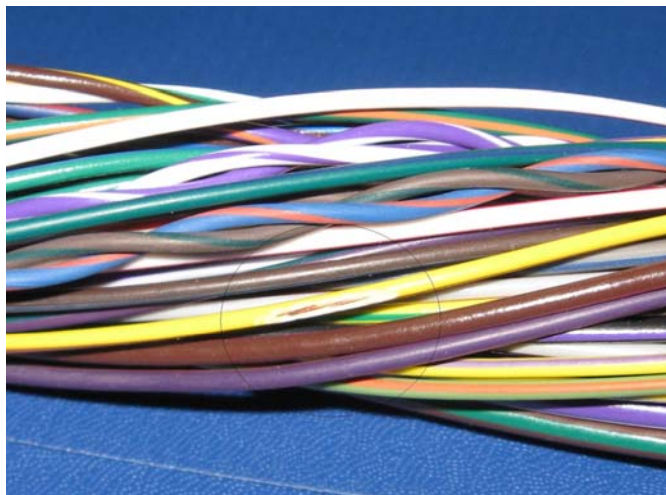
Photo 1: Minor primary wire damage

Wire and cable damage tends to fall into two categories, minor and severe. Minor cable damage is typically limited to the outer cable insulation material being pinched or scraped which degrades the dielectric and environmental performance of the wire. The damage may or may not expose the primary conductor or EMI shield below the outer jacket. However, if not repaired, the jacket insulation may split or crack in service leading to corrosion, system failure or possibly an electrical arcing condition. Severe damage typically consists of broken wire strands or cables where the primary conductor strands have been cut or nicked severely. This type of damage is actually easier to address than the minor type because the decision becomes rather clear. Either replace the entire wire or install a splice kit. Splice kits, although undesirable, are relatively easy to install since the wires are already cut in half or close to it. System tear down is limited and numerous types of splice kits exist to make this type of repair. The minor damage type can be very frustrating because in many cases the primary conductor has only superficial damage and cutting a good conductor in half to facilitate installation of a splice is generally seen as undesirable. Yet, historically there has been no easy way to make these minor insulation repairs and provide decent reliability without tearing a large part of the system apart to access the damage area (Photos 1 & 2).

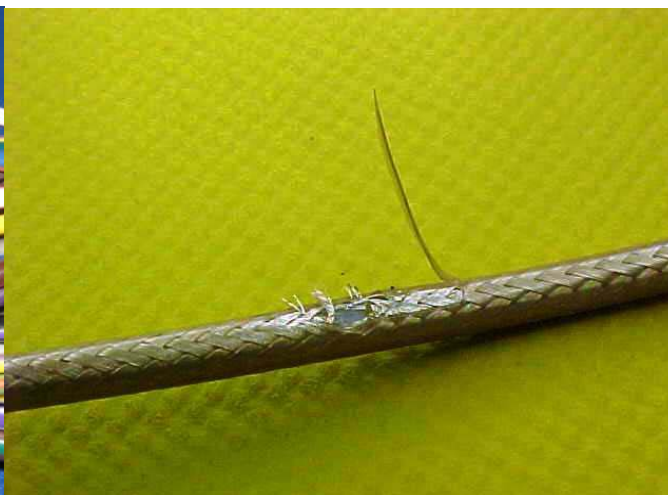
Photo 2: Minor shielded cable damage

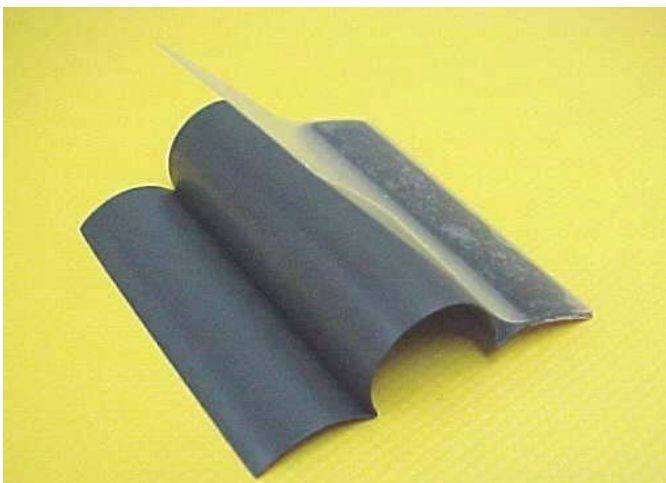
Photo 3: PRT-ES wrap around tubing

The PRT product can best be defined as an application modified heat shrink tubing. PRT is made from standard cross-linked polyolefin heat shrinkable tubing, conforming to the requirements of Mil-I-23053/5, Class 1. PRT is created by longitudinally splitting the tubing and laminating a transfer adhesive along one of the split edges. A special acrylic pressure sensitive adhesive designed for adhesion to low surface energy plastics and oil-contaminated surfaces is used. The adhesive provides an outstanding bond over a service temperature of -40°C to 150°C, exhibits good fluid resistance properties and is flame retardant allowing the PRT product to pass UL224, VW-1 flammability requirements. The tubing material has also been re-sized to accommodate the circumference change associated with the material overlap inherent to a wrap around tubing. The wrap around design allows other materials to be added such as EMI shielding and hot melt adhesive layers resulting in a very versatile repair product. Currently PRT is available in four variations including the original standard split tubing (PRT), an EMI shielded version (PRT-S), an environmentally sealed tubing (PRT-ES) and an environmentally sealed shielded cable repair kit (PRT-1553). The product provides wrap around repair capability to wire and cable diameters as small as .040 inch to over 5.0 inches (Photo 3 & 4).

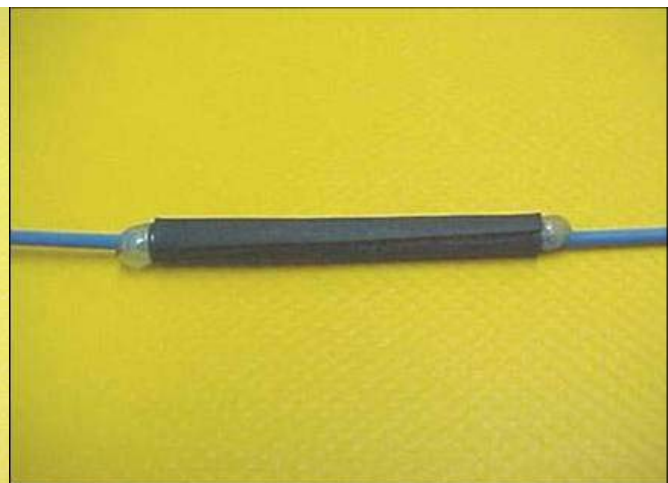
Photo 4: Finished PRT-ES repaired wire

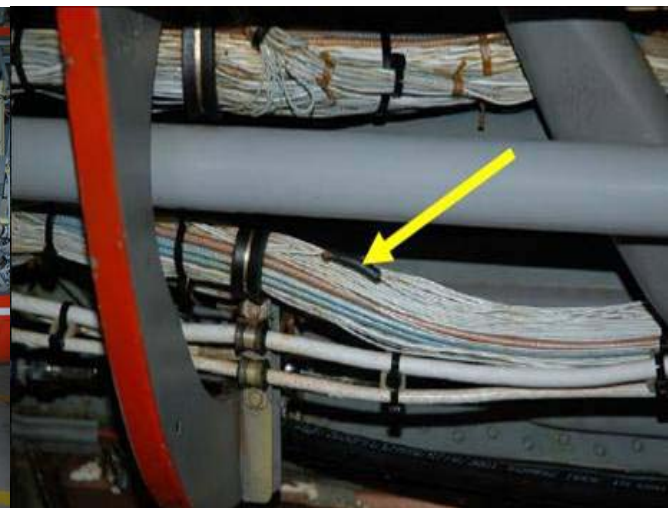
Photo 6: PRT-ES Installed repair

The US Coast Guard made several prototype installations and ultimately installed the PRT-ES product on a 6570 helicopter which had a Mil-W-22759/34 wire with insulation damage (Photo 5 & 6). This vehicle logged over two years and 1,407.1 flight hours with the PRT-ES repaired wire in place. The installation was made per the Zippertubing installation instructions and was located in an area within the operational temperature range of the PRT-ES product. Unfortunately, the installation was also exposed to a variety of fluids that Zippertubing recommended be avoided. The wire harness and repair sleeve were soaked with hydraulic oil, possibly jet fuel and an anti-corrosion compound known as Fluid Film (Eureka Chemical Co). None of these fluids had ever been tested by Zippertubing, but the jet fuel and hydraulic oil were suspected to be detrimental to the overall lifespan and performance of the PRT-ES repair product.

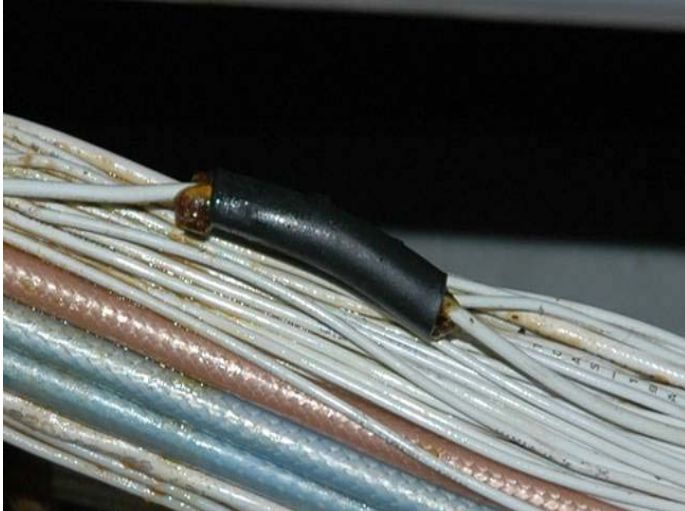
Photo 7: PRT-ES as removed after 1,407.1 hours

At the end of the 2 year (1,407.1 hour) operational period the PRT-ES repair was examined and found to be soft, swollen and sticky. At that time the repair was still functioning and had exhibited no evidence of a service failure (Photo 7). The US Coast Guard removed the repair and submitted it along with a request for a materials evaluation to the Air Force Research Laboratory/Materials Integrity Branch, Dayton, Ohio. The AFRL/MLSA undertook a detailed examination of this sample and reported it's finding back to the US Coast Guard in June 2007¹. The following is a synopsis of the results from the AFRL/MLSA report. The author encourages the reader to obtain a copy of this report to understand all aspects of this evaluation. The AFRL/MLS evaluation report stated the following;

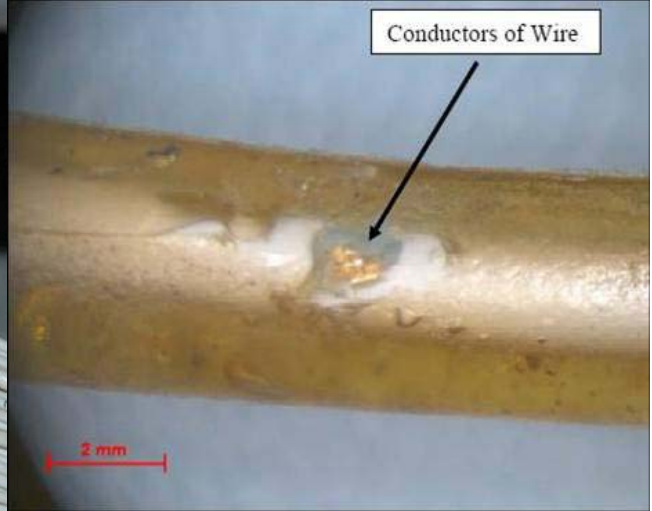
Photo 8: No wire conductor corrosion

- Aliphatic hydrocarbons and esters identified in the chemical analyses caused the environmental hot melt seal material and the edge seal adhesive to become semi-solid at the end fillets and along the length of the seam edge overlap. The environmental seal, however, was not compromised and the hot melt seal beneath the black tubing remained solid and provided protection and insulation in the damaged area of the wire (Photo 8).

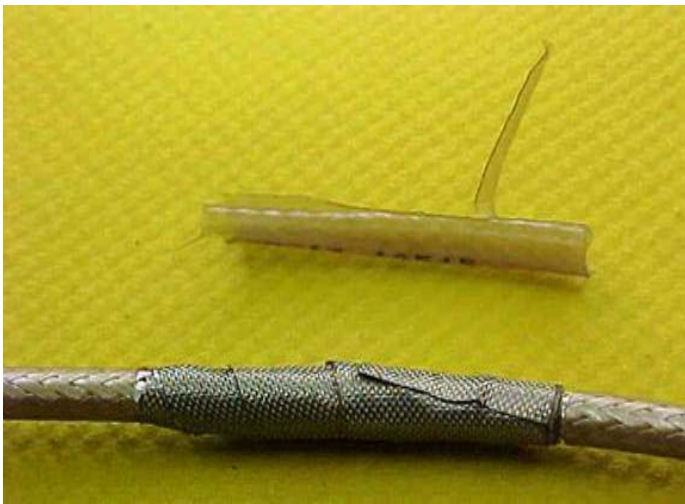
Photo 9: RG-180 shield repair with EMI tape

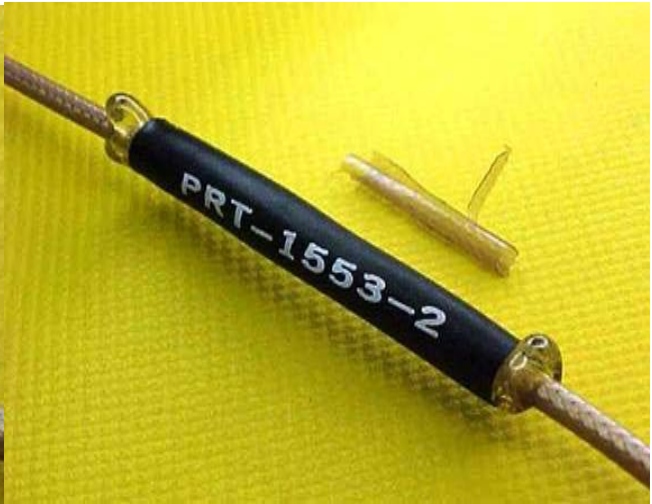
Photo 10: Finished RG-180 repair test cable

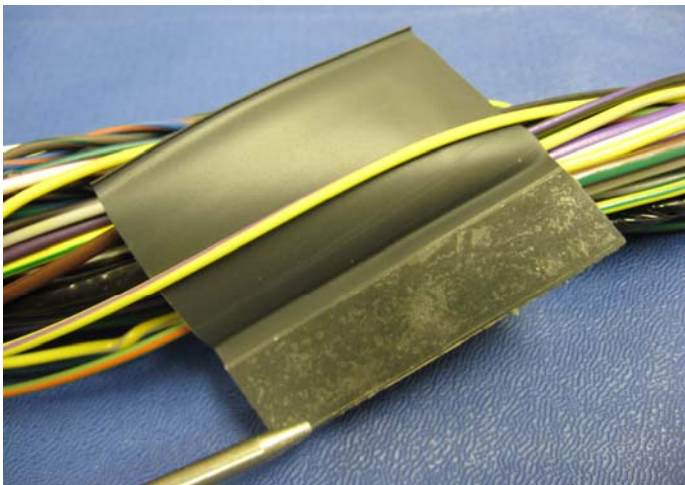
Photo 11: PRT-ES tubing slipped under wire

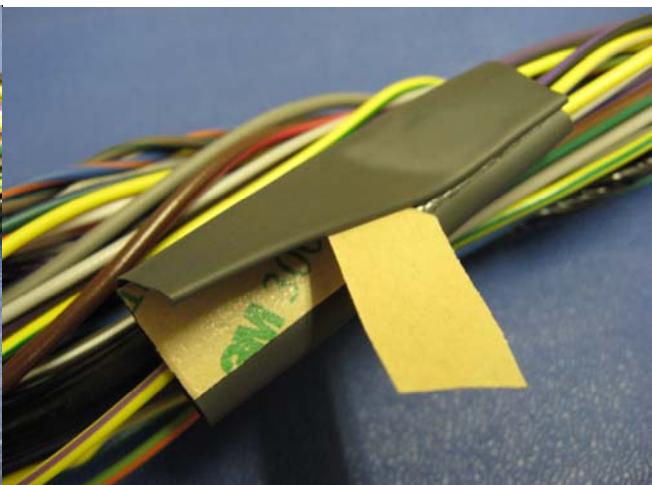
Photo 12: PRT-ES adhesive fully covered

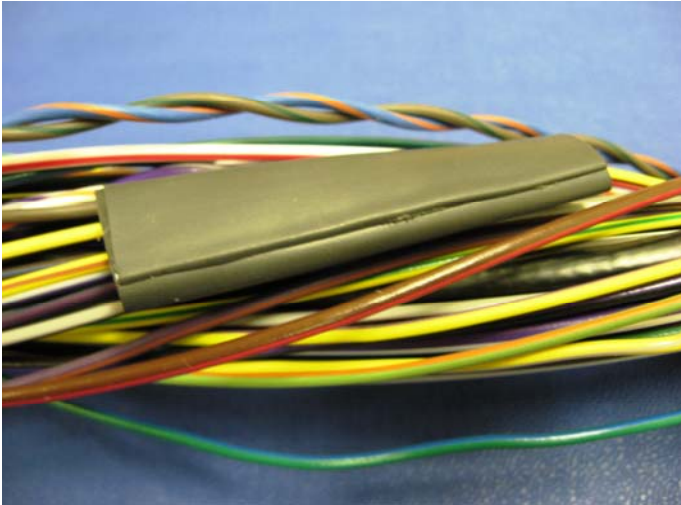
Photo 13: PRT-ES completely closed around wire

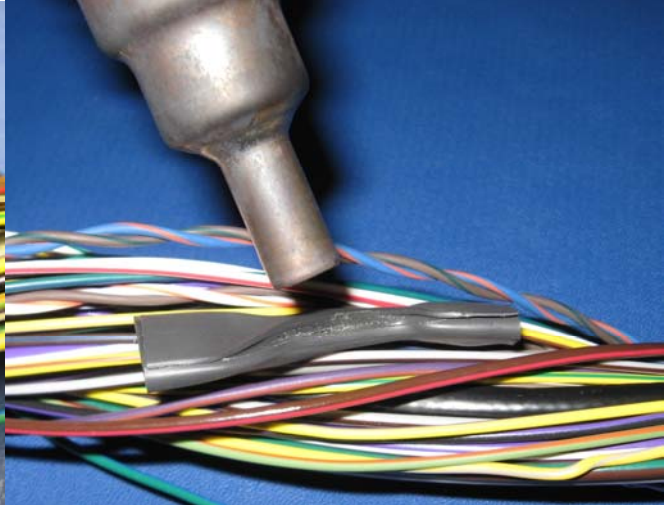
Photo 14: Reducer nozzle shrinking overlap area

- 7) Apply heat to the adhesive overlap area only! Fully shrink the overlap area over the entire tubing length first. This process heat-sets the adhesive system and minimizes any tendency for the tubing to tear open during heating. Don't be alarmed when this area curls up, continued heating will cause it to eventually lay down flat. The adhesive overlap area requires extra heat soak time due to its thickness and to insure complete recovery of the inner layer (Photo 14 & 15).

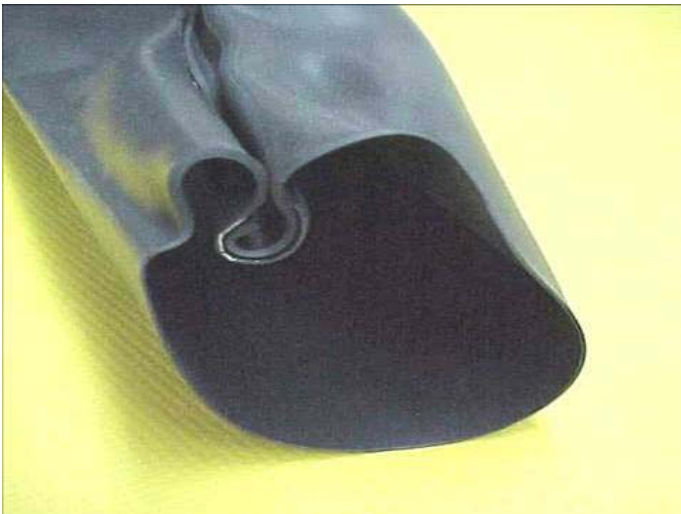
Photo 15: Overlap area curled up upon heating

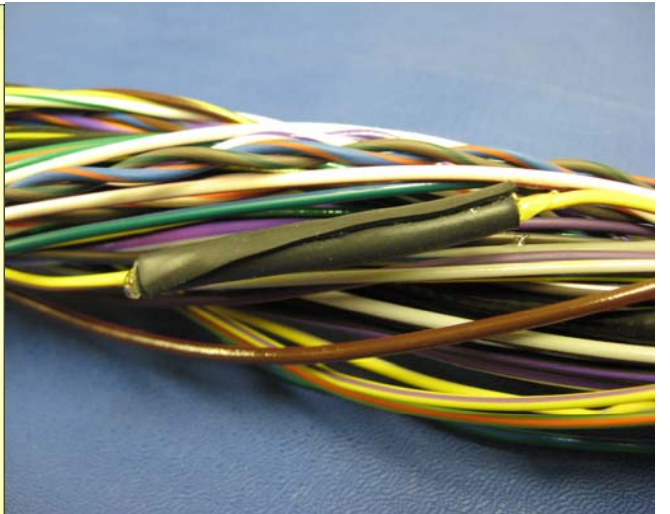
Photo 16: Finished PRT-ES repair

- 8) After the overlap length has been shrunk, allow the PRT to cool briefly and then apply heat to the remaining tubing circumference as necessary.
- 9) When the tubing is cool enough to touch, rub your thumb along the warm overlap edge to insure that the tubing edge is not lifted. The rubbing action will also cause any exposed adhesive to ball up ahead of your thumb and be removed. With PRT-ES tubing do not rub the seam until the hot melt material has cooled and solidified (Photo 16).

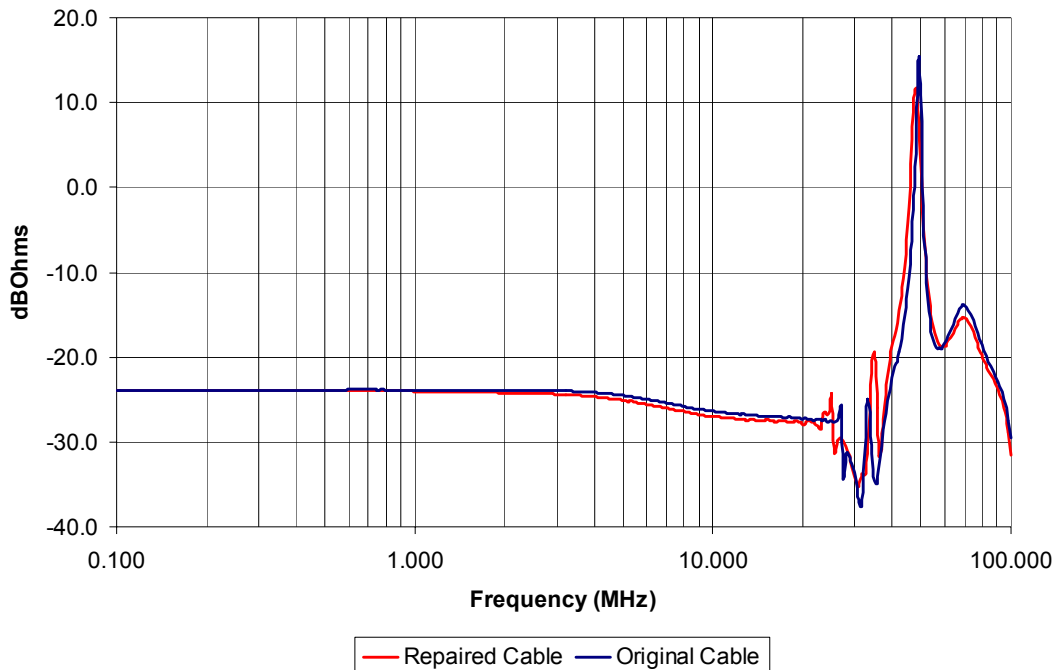
Transfer Impedance RG-180

Figure 1: RG-180 performance @ 100 KHz to 100 MHz

Interference Lab (AFRL/SNRA), Wright-Patterson AFB, Ohio, to perform EMI shielding tests on RG-180 coax and Mil-Std-1553 data bus cables that had been repaired using the PRT-1553 kits. The results were reported in a test report dated 9 April 2007². Two sets of test cables were fabricated from Mil-Std-1553 data bus cable and RG-180 coax cable. One of each cable type was purposely damaged with a defect falling within the PRT-1553 damage parameters. The cables were repaired using the appropriate sized Zippertubing PRT-1553 kits (Photos 2, 9 & 10 illustrate the RG-180 damage and repair). The repaired cables were sent to the IDAL laboratory for testing. This testing was performed as a comparison to the same type of testing that had been performed in February 2007 for the US Navy located at Patuxent River, MD³. Testing performed in February had shown that the technique did not yield good results, *“when a large section of the cable shield (approximately 2 inches) was removed and repaired with the Zippertubing product.”* The new test effort evaluated cables with damage levels within the prescribed Zippertubing product limitations. The test cables used for this test were the same “control cables” used in the February testing. Figures 1 thru 8 show the shielding performance for Transfer Impedance and Induced Voltage from 100 KHz through 18 GHz for the April 2007 tests. The data illustrates that there is essentially no difference between the original undamaged cable data and the PRT-1553 repaired cable data! The two sets of data follow each other so closely that in many instances it is hard to distinguish the control and the repair curves.

The IDAL report concluded that, *“the transfer impedance and radiated field results for the repaired cables were similar to the baseline cables. It is not clear how the cables may have performed if an evaluation had been performed on the cables with the damage present prior to repair due to the small amount of damage.”* This laboratory report’s conclusion infers that perhaps a damaged cable with no repair at all would have performed with similar results. Such a point is sheer conjecture and it’s hard to imagine repair personnel ignoring even minor shield damage when evaluating the best repair method for a damaged shielded cable. Allowing any piece of electronic equipment, let alone a commercial or military aircraft, to operate with a shielded cable containing known shield damage is asking for trouble.

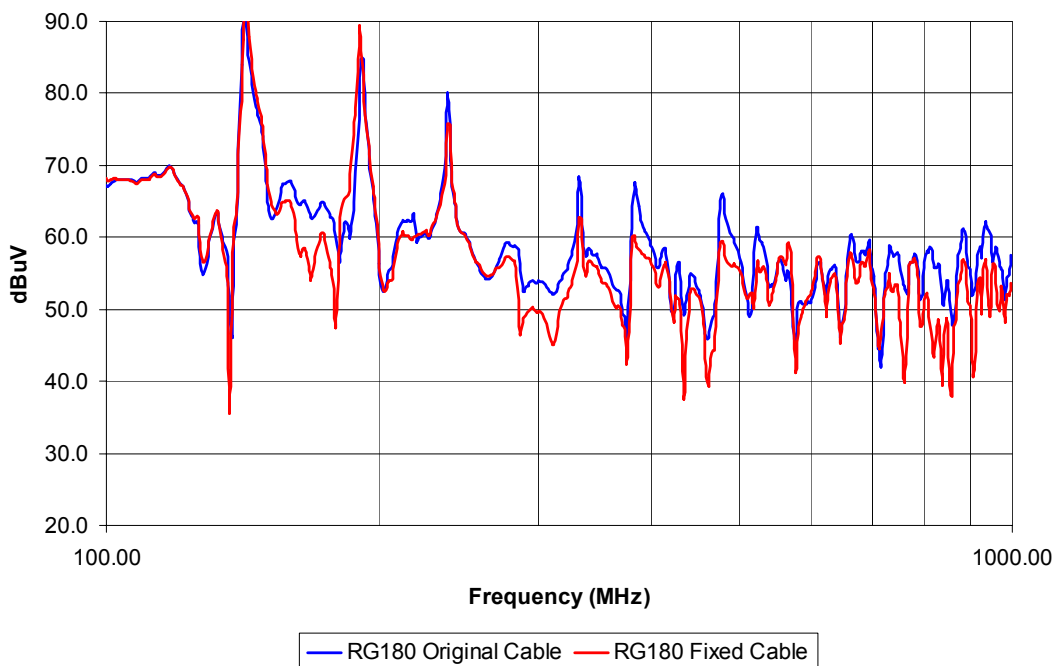
Induced Voltage for 100 V/m Field

Figure 2: RG-180 performance @ 100 MHz to 1 GHz

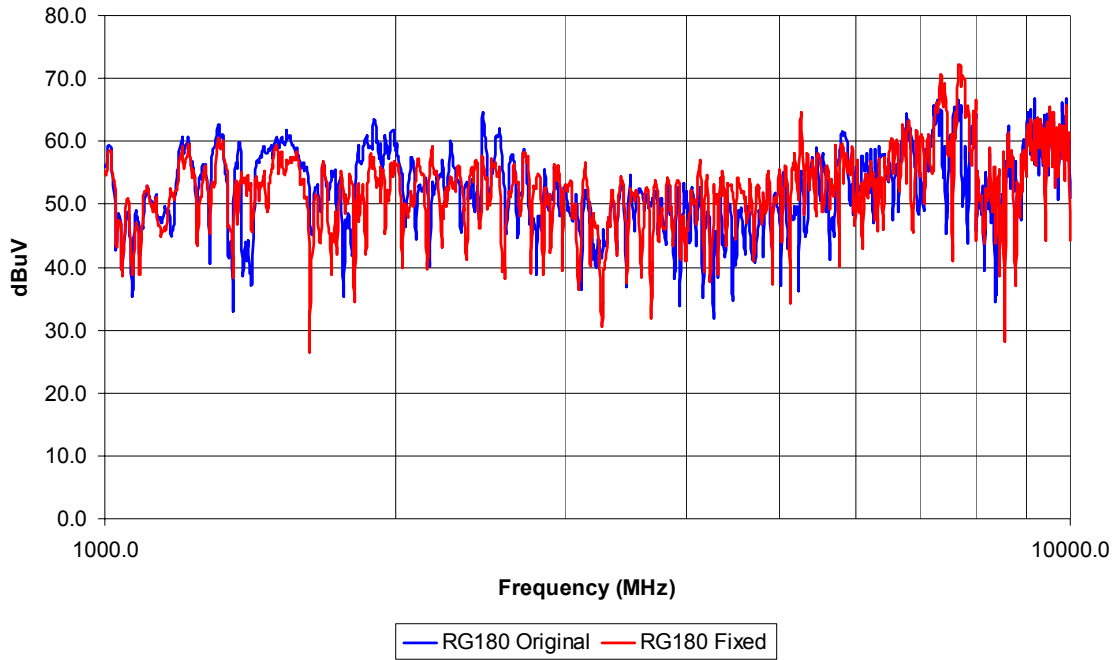
Induced Voltage, 100 V/m Field

Figure 3: RG-180 performance @ 1 GHz to 10 GHz

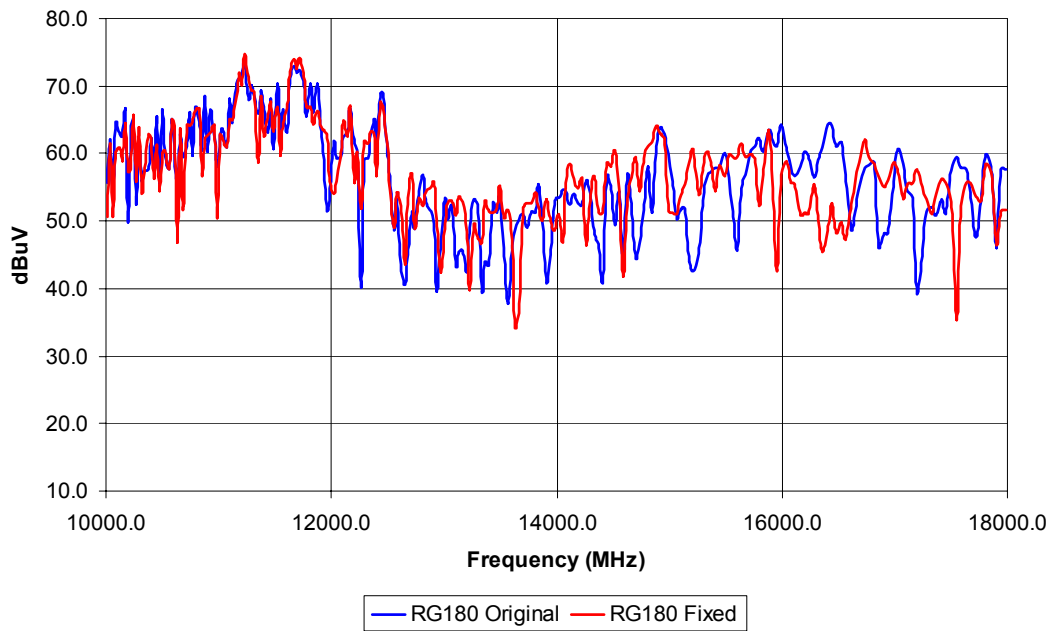
Induced Voltage, 100 V/m Field

Figure 4: RG-180 performance @ 10 GHz to 18 GHz

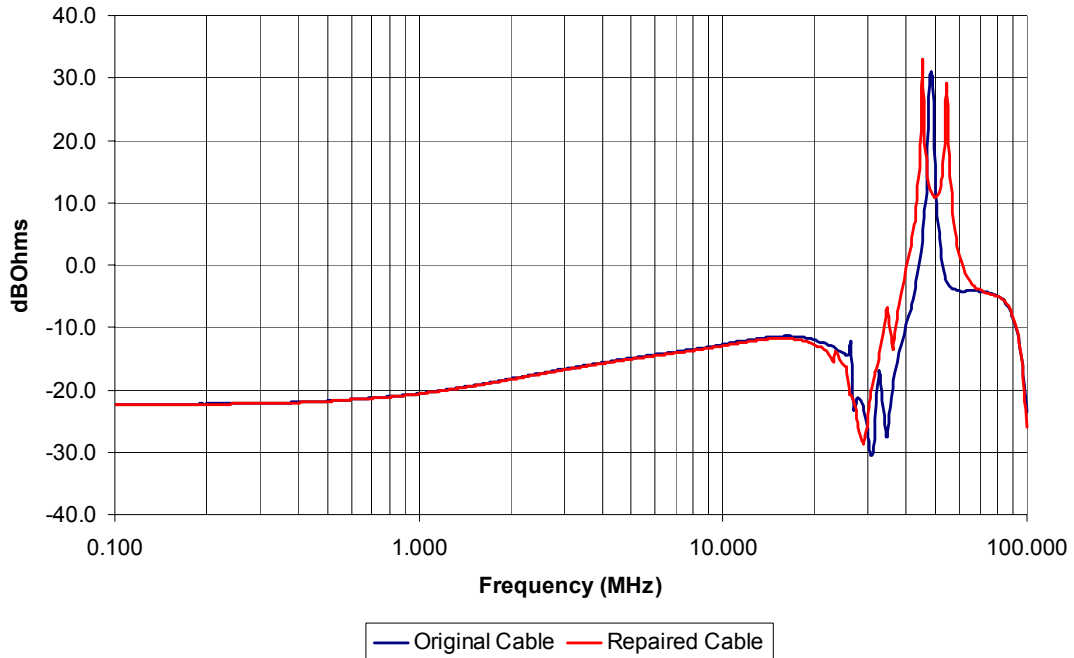
Transfer Impedance MIL-STD-1553

Figure 5: Mil-Std-1553 performance @ 100 KHZ to 100 MHZ

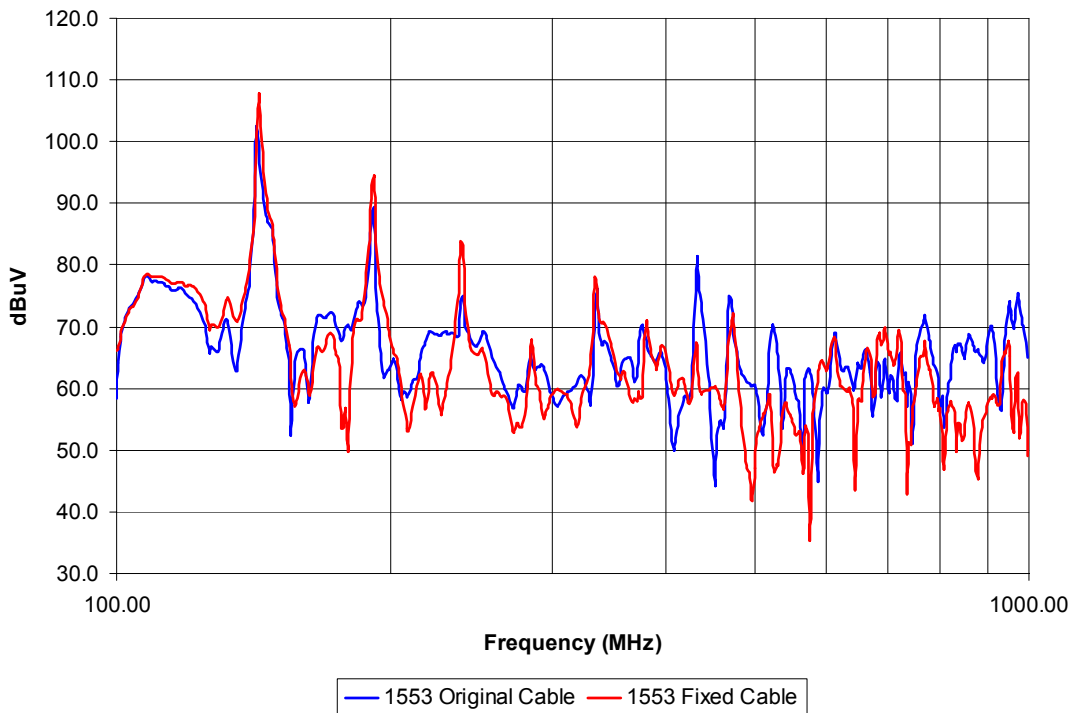
Induced Voltage, 100 V/m Field

Figure 6: Mil-Std-1553 performance @ 100 MHz to 1 GHz

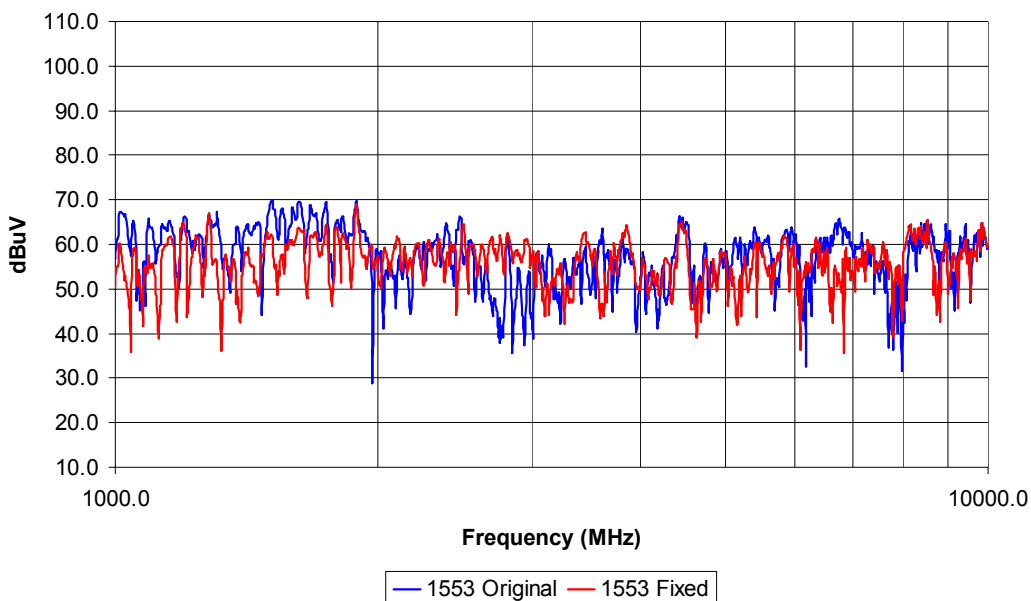
Induced Voltage, 100 V/m Field

Figure 7: Mil-Std-1553 performance @ 1 GHz to 10 GHz

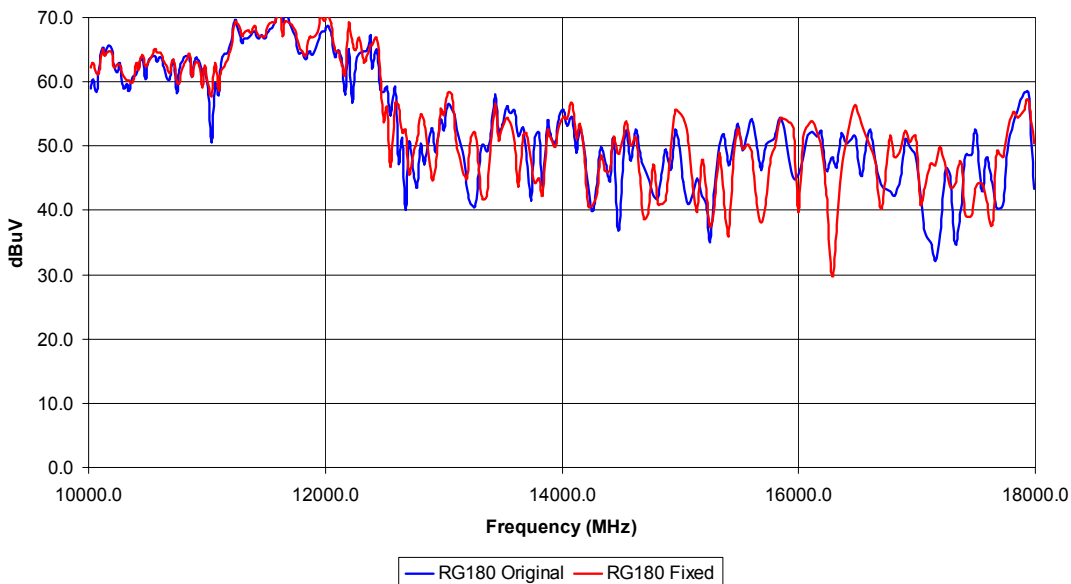
Induced Voltage, 100 V/m Field

Figure 8: Mil-Std-1553 performance @ 10 GHz to 18 GHz

Note:
Figure 8 graph from the Integrated Demonstrations & Applications Laboratory (IDAL), Electromagnetic Interference Lab, AFRL/SNRA, WPAFB, OH is misidentified as RG-180 instead of Mil-Std-1553 cable.
