Very Large PRT-ES Installations (ZT07-98-003)

Cable Diameters > 1.88 inch

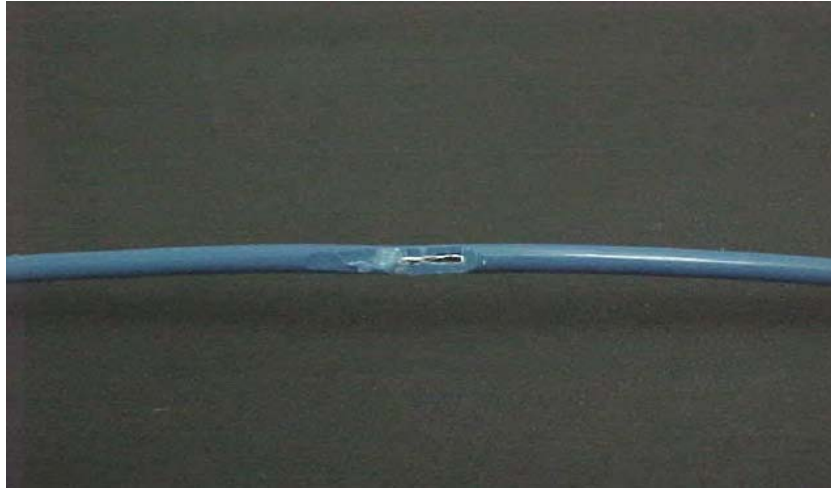
Photo 1: Typical wire or cable insulation damage.

3) Use a razor knife to remove any protruding pieces of cable insulation that do not dress down smooth and flush with the original jacket. (Photo 1)

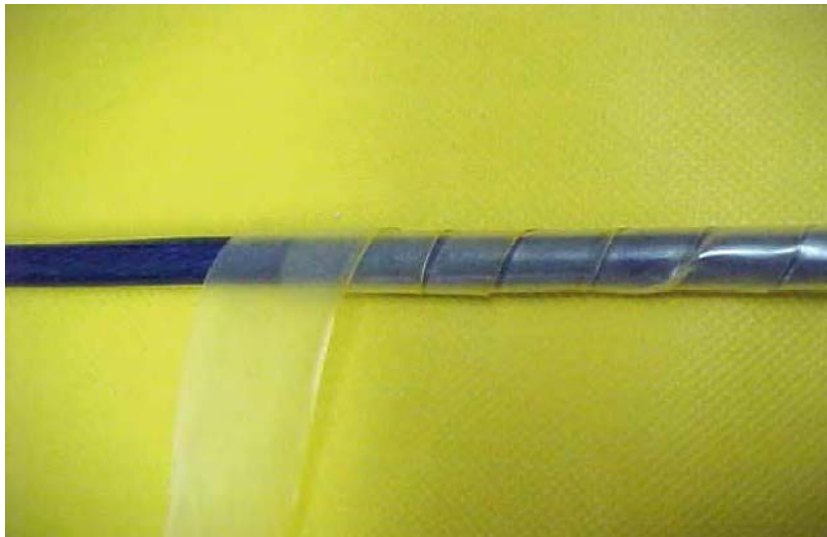
Photo 2: Z-Block tape wrapped around cable.

4) Use the Z-Block hot melt tape and helically wind the tape around the cable over the entire area to be repaired so that each tape wind butts up against the previous one or overlaps by approximately ¼ - ½ inches. (Photo 2) Be sure to remove the paper liner from the amber colored tape prior to wrapping the cable. If the damaged area of the cable has deep nicks or voids, cut pieces of the Z-Block tape and pack the void areas prior to applying the tape over wrap. The hot melt tape does not have a self-stick backing! You may find it advantageous to touch the hot edge of the heat gun to the first and last winds of tape as necessary to help fuse it together and hold it in place.

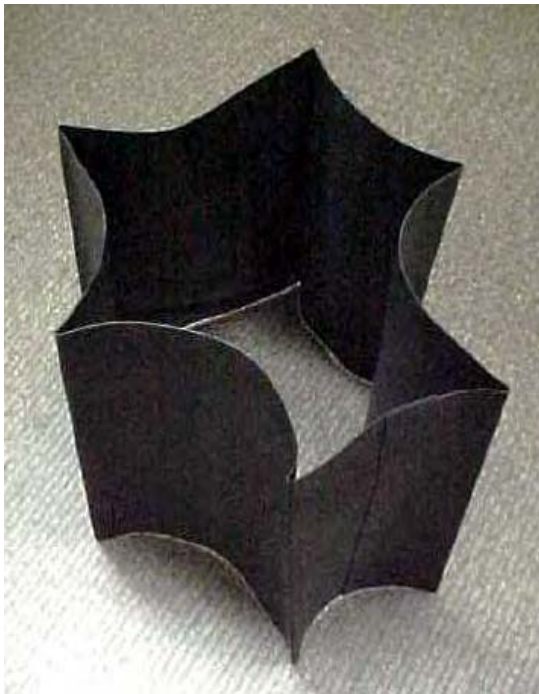
Photo 3A: Prior to shrinking.

the release liner from the first piece of tubing in short section and align and bond the second piece in this fashion over the entire part length. Rub the completed lap joint with your thumb to insure a good bond. Repeat this procedure with additional pieces of tubing as necessary. When assembled correctly, you will have a large single piece of PRT™ Tubing (made of multiple piece sections) that when wrapped around the cable will allow you to seal it closed into a large single piece of tubing. See Photo #3A below for a typical view of an assembled piece of tubing.

Note: The pre-packaged PRT™ Tubing kits and material fabricated by the user from Table 1 components will consist of multiple pieces and have multiple overlap seam lines. In the pre-shrunk condition these materials will exhibit an unusual “star-like” appearance. (Photo 3A) This condition is normal for multi-piece PRT™ Tubing prior to applying heat. The fully shrunk PRT™ Tubing insulation jacket will have a smooth, round appearance. (Photo 3B)

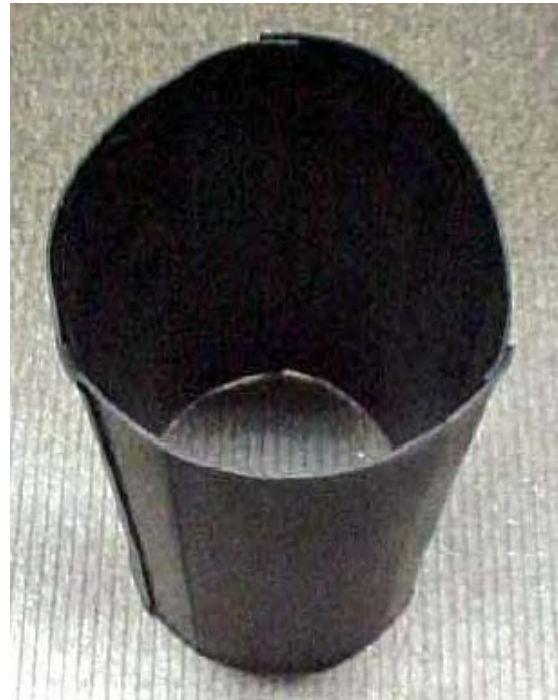
Photo 3B: Fully shrunk condition.

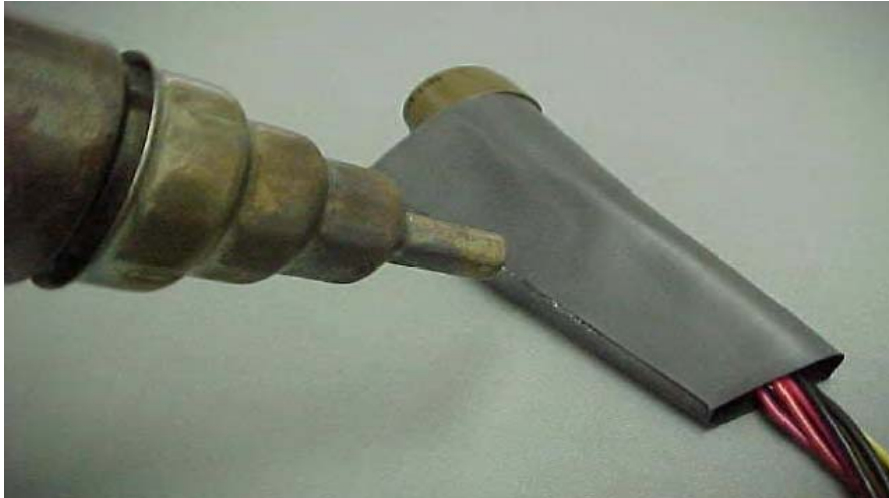
Photo 4: Nozzle focused near tubing center on overlap seam

- a) PRT™ Tubing when used in conjunction with Z-Block hot melt tape requires the use of a hot air type of heat gun with a temperature setting of approximately 150-160°C to shrink the tubing and allow the hot melt adhesive to flow. Always use a heat gun with a small reducer nozzle that will localize the heat stream. (Photo 4)

- b) Begin shrinking the PRT™ Tubing by directing the heat source at the adhesive overlap area near the center of the repair tubing. (Photo 4) Apply heat to the adhesive overlap area only and work from the center towards the ends! The overlap area will tend to curl up into a “U” shape as it is heated. (Photo 5) Continue applying heat in short bursts to this area until the surrounding tubing begins to pull the “U” shape back down flat. Do not be afraid to apply extra heat to the overlap area, as it will take extra dwell time for the inside layer of the overlap to begin to shrink. Do not be alarmed if the outer layer of the overlap flap tends to lift off the adhesive and curl back slightly during initial heat exposure. With continued heating this lifted area will generally lay back down on its own, if not, lightly tap the lifted edge as necessary with a wooden Popsicle stick? Do not squeeze the tubing when tapping the lifted lip down. Use extreme caution when touching the tubing as it will be hot and sticky. Shrink the multiple overlap seam areas over their entire part length before attempting to recover the remaining tubing.

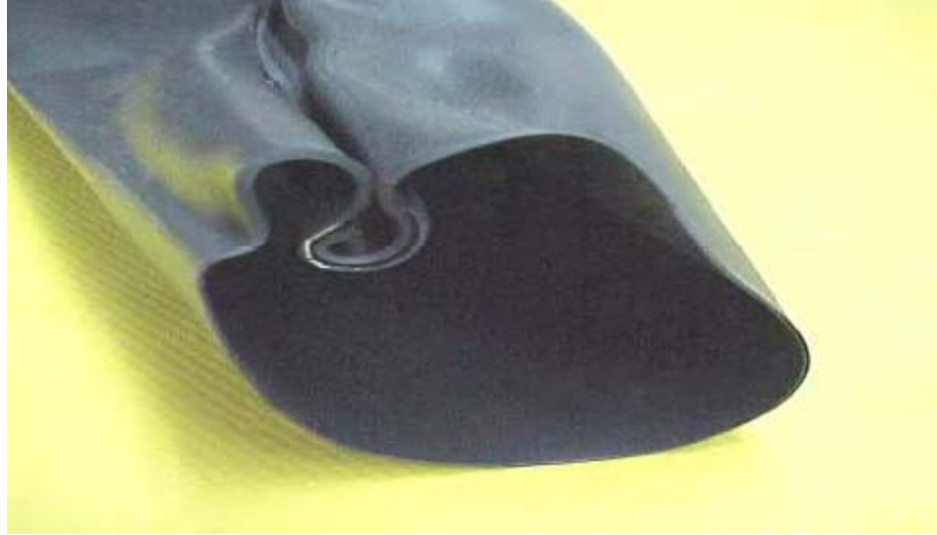
Photo 5: Overlap seams curled up prior to full shrinkage.

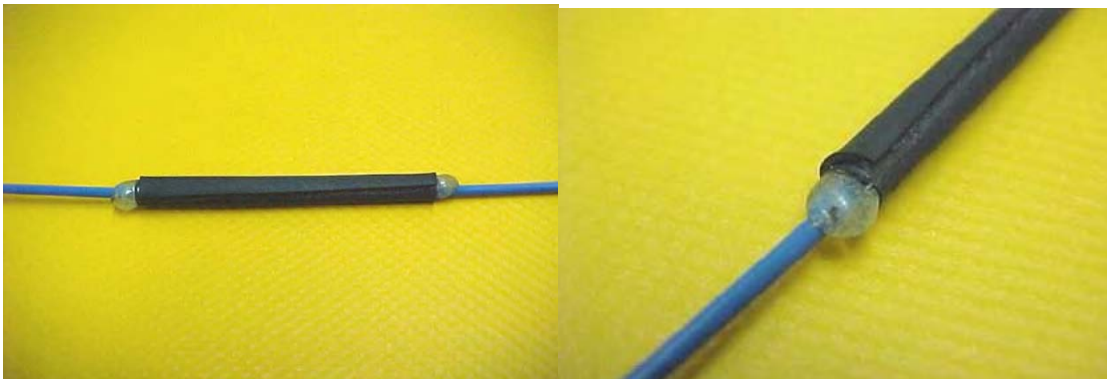
Photo 6: Adhesive fillet

source away and let the tubing cool momentarily if it appears that the overlap seam is being pulled apart. Once the overlap seam has fully shrunk you may find that most of the remaining tubing has also shrunk. Apply the heat to any remaining tubing areas to smooth out any wrinkles and cold spots. Once the tubing is fully shrunk, apply heat over the entire tubing length and circumference in a smooth and even motion insuring that the hot melt adhesive is flowing and has oozed out from under both ends of the tubing evenly. The finished part should have a fillet of adhesive at each end. (Photo 6)

- d) Do not attempt to remove the hot melt adhesive fillet! Do not be alarmed if the adhesive fillets are uneven around the circumference of the cable or undesirable looking cosmetically. In general, a fillet that covers the entire jacket end circumference of the repair sleeve is what's important and not the cosmetic look of the fillet.

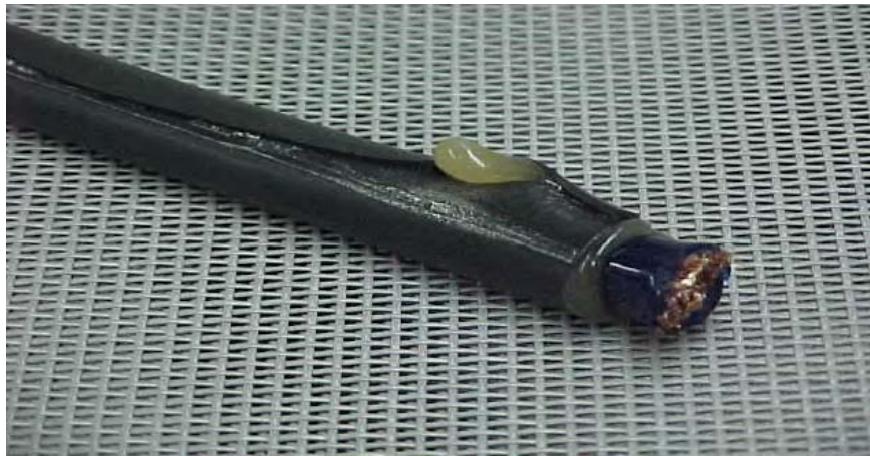
Photo 7: Typical overlap seam rupture

Keep the tape wrap buildup to a minimum. A smooth single layer wrap is ideal. Too much tape could cause a seam rupture (Photo 7).

The most common problem likely to occur when installing PRT™ Tubing and Z-Block tape materials is a seam rupture. This condition is where the molted Z-Block hot melt tape breaks through a section of the overlap seam during installation. (Photo 7) Seam ruptures are most likely to occur during the learning phase of PRT-ES installation. Once the proper installation technique has been mastered this problem will disappear. Seam ruptures occur for two main reasons and both can be controlled by the installer.

- 1) Sizing:** The PRT™ Tubing selected in Table 1 was too small for the cable diameter being repaired.
- 2) Heating:** The installer applied too much heat, too quickly to the PRT™ Tubing and Z-Block tape.

A repaired seam rupture will never look quite as good cosmetically as the seam areas that were properly installed. However, that does not mean that a seam repair cannot be used. As long as there is a thin bead of the “Z-Block” hot melt adhesive present along the overlap split line in the area of the rupture you have a usable assembly. Since the entire jacket is sealed with the hot melt adhesive there is no way for the environment to find its way to the repaired defect area. The same condition would exist if the rupture were not repaired. However, repairing a rupture is desirable since it eliminates the raised lip condition (Photo 7) which could create a potential snag problem resulting in further damage.
