PRT-ES Tubing Installation (ZT03-98-001)

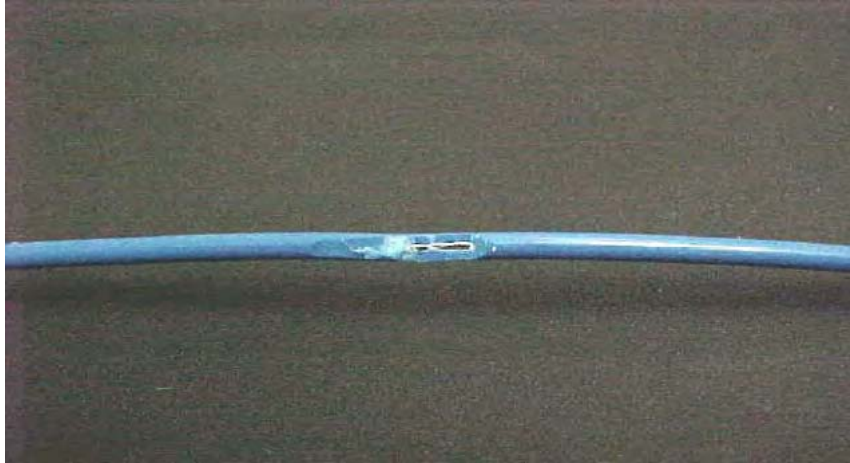
Photograph number one illustrates a classic example of an electrical wire that has suffered insulation damage due to harness chaffing. The damage level is severe enough to cause a possible short circuit condition and at the very least conductor corrosion and failure if not repaired. However, the conductor is still intact and cutting the wire in two to install a wire splice is typically undesirable as this type of repair may affect the wire resistance and would create a very stiff area that may lead to future failure. The PRT-ES product was specifically developed to create a quick, reliable and flexible repair that is virtually as good as the original wire insulation as long as the primary conductor has not been damaged. PRT-ES is not a splicing device! Never use PRT-ES if the primary conductor has been severely damaged. The advantage of using PRT-ES on minor insulation damage is that it can be installed quickly, with minimal harness and connector disassembly and is far more rugged and reliable than a temporary tape wrap repair. A PRT-ES repaired wire can provide many years of service assuming it's installed correctly and is not exposed to environmental parameters beyond its design limits.

Photo 1: Typical wire insulation damage

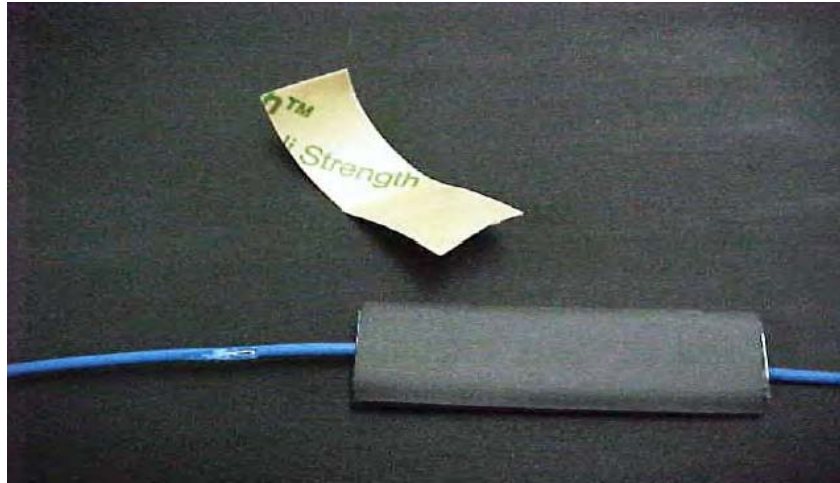
Photo 2: PRT-ES Tubing installed around damaged wire.

- 3) Cut the PRT-ES Tubing from the spool or roll using scissors. The cut length should long enough to cover the entire defect are and extend beyond it by 1/2 inch minimum on each end for cable diameters up through 3/4 inches. For cable diameters greater than 3/4 inch increase the extension to 1.0" minimum. Wrap the PRT-ES tubing around the damaged wire so the paper release liner faces the installer. Peel back a portion of the release liner (not all) and expose the adhesive. Position the non-adhesive edge of the tubing over the exposed adhesive section and align so all the adhesive is covered but no more. Never over-wrap the tubing leaving a loose flap of material at the overlap. Doing so could result in an undersized tubing condition and lead to the tubing tearing apart during the heating process. Begin bonding the tubing overlap edge to the adhesive. Avoid contacting the adhesive with your fingers as much as possible. Remove short sections of the release liner until the entire tubing length is sealed closed. Rub the overlap seam area firmly using your thumb to work out any wrinkles. Minor wrinkles will disappear when the tubing shrinks. (Photo 2).

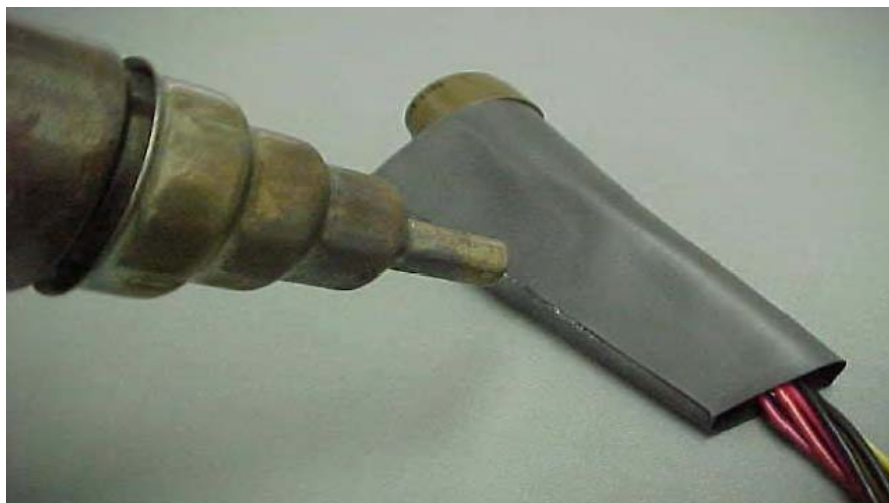
Photo 3: Heat Gun reducer nozzle

adhesive overlap area near the center of the tubing (Photo 3). Apply heat to the adhesive overlap area only! The overlap area will tend to curl up into a “U” shape as it is heated (Photo 4). Continue applying heat in short bursts to this area until the surrounding tubing begins to pull the “U” shape back down flat. Do not be afraid to apply extra heat to the overlap area, as it will take extra dwell time for the inside layer of the overlap to shrink. Do not be alarmed if the outer layer of the overlap flap tends to lift off the adhesive and curl back slightly during initial heat exposure. With continued heating this lifted area will generally lay back down on its own, if not, lightly tap the lifted edge as necessary with a wooden Popsicle stick? Never squeeze the PRT-ES when tapping the lifted lip down and always use caution when touching the tubing as it will be hot and sticky. Shrink the overlap seam area along the entire part length before making any attempt the shrink the remaining tubing.

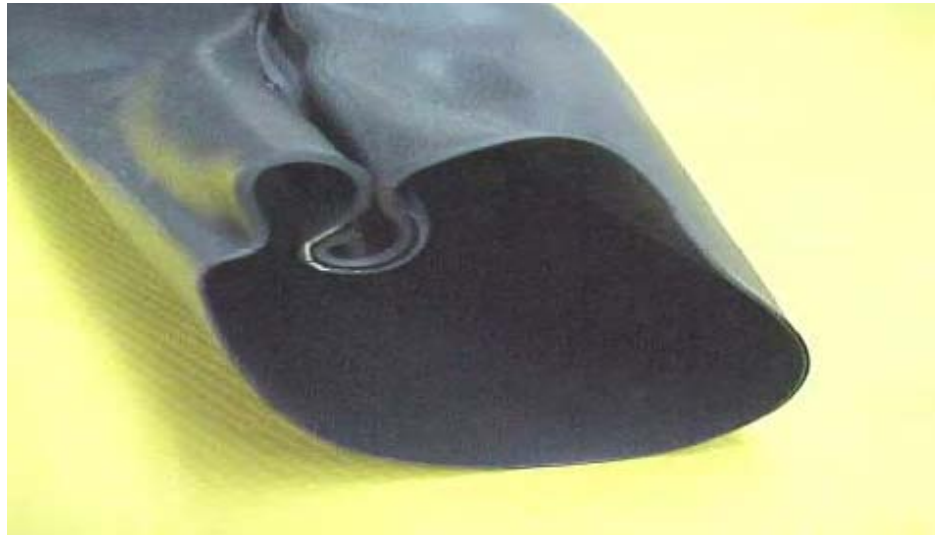
Photo 4: Overlap seams curled up prior to full shrinkage.

The best technique is to slowly heat the entire overlap seam length and work from the center towards the ends. Too much heat, too quickly, in one location may cause the hot melt adhesive to expand unevenly and possibly rupture the overlap seam. Refer to the Troubleshooting section at the end of this document. The key to a successful installation is to “sneak up” on the tubing with the heat source. Do not be afraid to pull the heat source away from the tubing as necessary and let the tubing cool slightly if it appears that the overlap seam is being pulled apart. Once the overlap seam is fully shrunk you may find that most of the remaining tubing has also shrunk (especially on small size wires and cables).

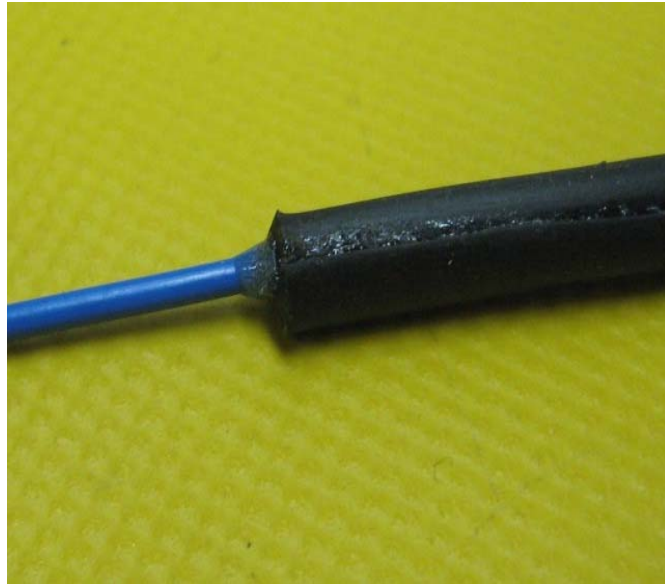
melt adhesive begins to flow and ooze out from both ends of the tubing. The finished part should have a fillet of adhesive at each end (Photo 5).

Photo 5: PRT-ES Sleeve with fillets

- 8) Do not attempt to remove the hot melt adhesive fillet! Do not be alarmed if the adhesive fillets are uneven around the circumference of the wire or undesirable looking cosmetically. You can re-apply heat to the fillet area and dress the excess. In general, a fillet that is exposed over the entire end circumference of the repair sleeve is what is important and not the cosmetic look or how uniform the fillet itself is.

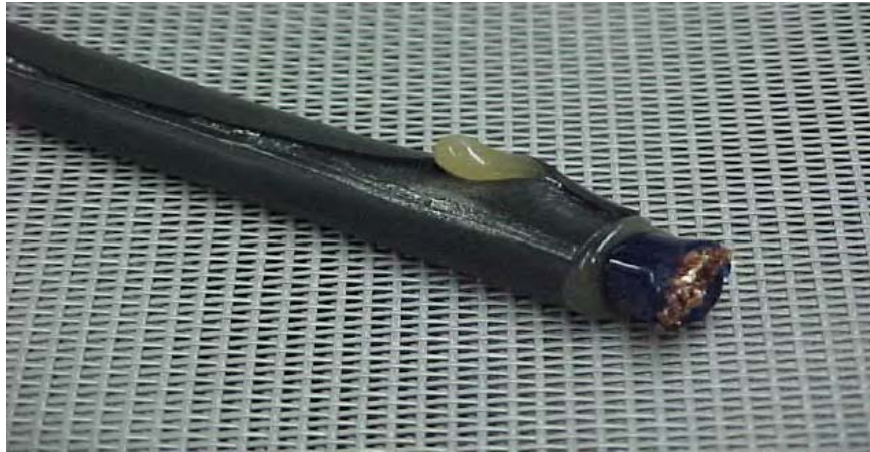
The most common problem likely to occur when installing PRT-ES tubing is a seam rupture. This condition is where the molted Z-Block hot melt tape breaks through a section of the overlap seam during installation (Photo 6).

- 1) **Sizing:** The PRT-ES tubing selected in Table 1 was too small for the cable diameter being repaired.
- 2) **Heating:** The installer applied too much heat, too quickly to the PRT-ES tubing.

Photo 6: Typical overlap seam rupture

If a rupture occurs, verify that incorrect sizing was not the cause? If the cable outside diameter is very close to the upper limit of a size range shown in Table 1, consider increasing the PRT-ES size to the next larger size. Correct as necessary and attempt a new installation. If sizing is not the cause of the failure, then adjust the heating technique by applying the heat more slowly and evenly. Review the “sneak up on it” technique described in step #5.

Seam ruptures are undesirable and should be avoided. Cable assemblies with a diameter of less than 1/2 inch or those with a seam rupture in the immediate area of the cable damage should have PRT-ES jacket removed and replaced. Cables diameters greater than 1/2 inch exhibiting a seam rupture that is away from the actual defect repair area may be reworked and still provide a good environmental seal.

A repaired seam rupture will never look quite as good cosmetically as the seam areas that were properly installed. However, that does not mean that a seam repair cannot be used. As long as there is a thin bead of the "Z-Block" hot melt adhesive present along the overlap split line in the area of the rupture you have a usable assembly. Because the entire jacket is sealed with the hot melt adhesive there is no way for the environment to find its way to the repaired defect area. The same condition would exist if the rupture were not repaired. However, repairing a rupture is desirable since it eliminates the raised lip condition (Photo 6) which could create a potential snag problem resulting in further damage.
