## Custom Umbilical Cover for Robotic Inspection System

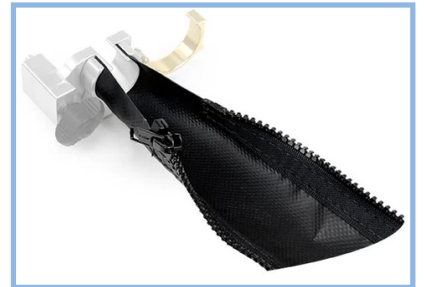
Zippertubing provided a customized version of their zipper-closed VNH-23 jacketing. The tough, coated-fabric, material was the perfect combination of flexibility and strength to provide rugged outdoor protection for their sensitive cables. For the closure, a strong, double-sided zipper was used to allow a quick and easy installation. Zippertubing design engineers were also able to customize the solution by including extensions at both ends of the sleeve to interface with the custom mounting brackets of the robot and power system.
