**CUSTOM THERMAL**  
PROTECTION

## Custom Thermal Protection Replacement

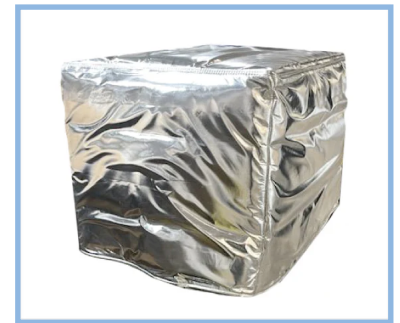
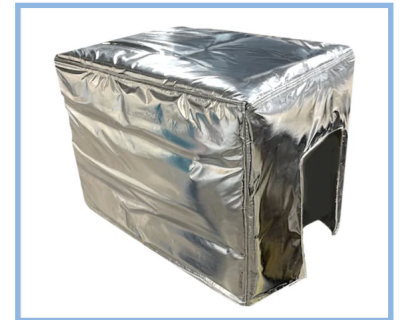
**Custom Ceramin Fiber Heat-Shielding with an exterior aluminized layer.**

Zippertubing engineers determined that the optimal solution for this application was a combination of Zippertubing's Ceramic Fiber Blanket, sandwiched between layers of our Amorphous Silica Cloth Fabric. This combination of materials offers exceptional temperature resistance while effectively minimizing heat transfer over extended periods. To prevent the Ceramic Fiber Blanket from shifting due to gravity and creating hotspots, the materials were quilted. Additionally, a layer of ALS-5 was added to the exterior to provide an aluminized finish. The part was constructed as panels, and then sewn together to create the necessary box shape.
